**Maryland Historical Trust**  
**State Historic Sites Inventory Form**

Survey No. B-4420

historic 220-228 West Baltimore Street  
1 North Howard Street

Siegel, Rothschild & Co. Umbrella Factory

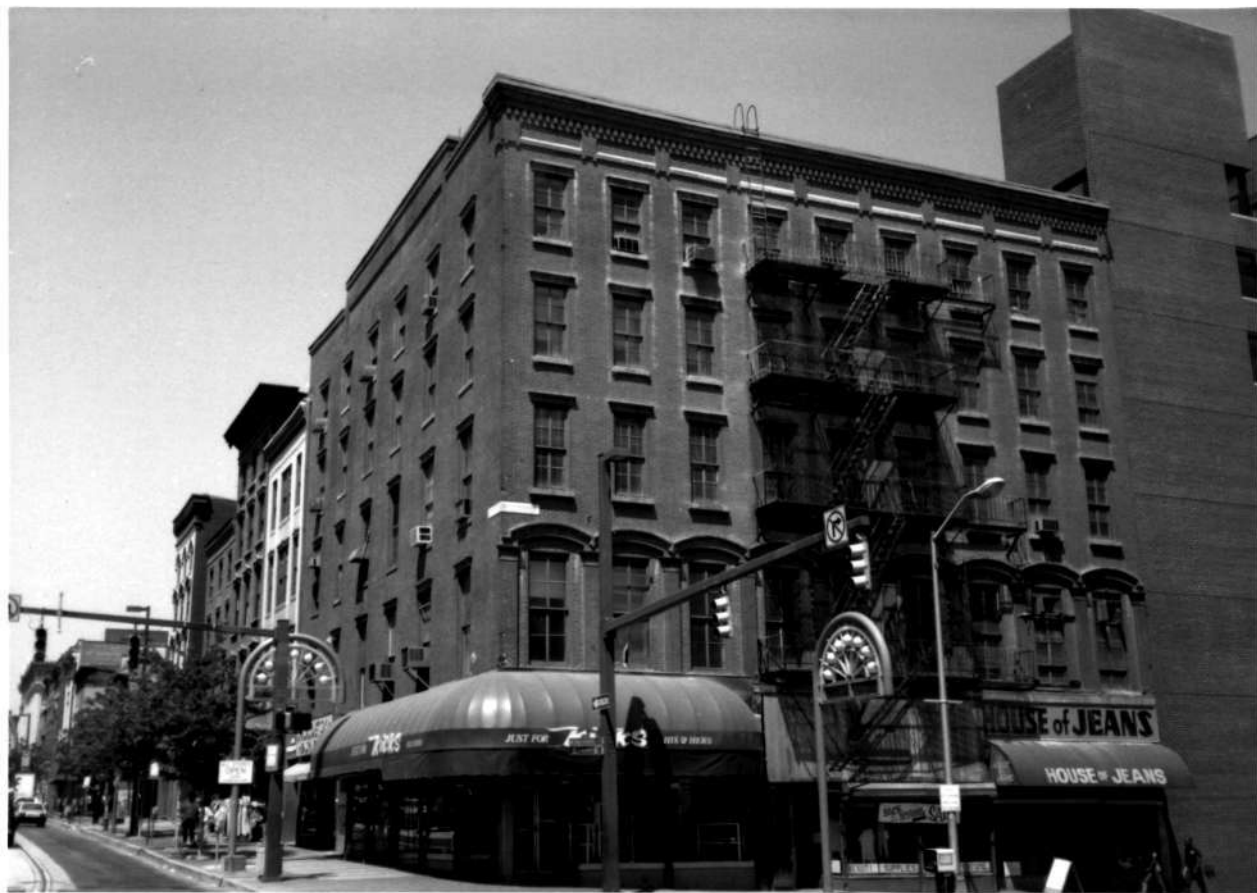
NW Elevation

The west facade faces North Howard Street. It has little ornamentation. The five-bay brick building is laid in stretcher bond. The height of each story decreases as the building rises. The first story is remodelled into three storefronts. Bay 1-3 (south to north) are part of the shop at #226 West Baltimore. The display windows in bays 2-3 are surrounded with the same turquoise panels as the facade. A roll-down theft guard protects the first story. Bay four is a narrow store front with glass windows flanking a recessed entrance of a glass door with sidelights and transom (which is now filled with an air conditioning unit). Brown painted aluminum covers the foundation wall of the display windows. Bay five contains a separate angled, entrance to upstairs offices, entitled "One North Howard." The brick walls are covered with brown painted aluminum. The recessed, glass double doors have a fixed transom.

Each upper stories' bays contain a 1/1 sash window with flat sills. The lintels have a profile of fillet, bead, ogee, fillet and back band. The second story windows to the south say "Baltimore Jewelry Co, Inc." and "Diamonds" on the panes. A few of the windows have been replaced with ventilators. The cornice is composed of molded corbelled bricks. A peaked parapet wall rises above the cornice; it has a recessed spandrel within.
